T. Damm¹, R. Barkmann¹, S. Galli², R. Willumeit-Römer³, C.-C. Glüer¹

¹Section Biomedical Imaging, Clinic of Radiology and Neuroradiology, University Hospital Schleswig-Holstein (UKSH), Campus Kiel, Germany

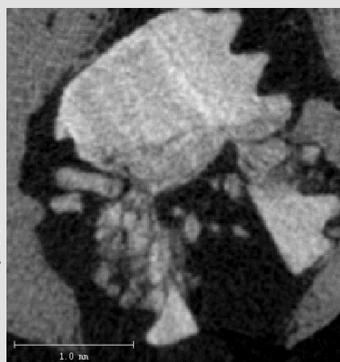
Partially fractured mini-screw of Mg10Gd

A time-lapse *in-vivo* μ CT study can elucidate the progression of the degradation, especially if the corrosion process is not taking place exclusively at the surface of the implants. Our data shows such progression along (possibly weak) zones into the alloy, which appears "fractured" due to this degradation scheme afterwards.

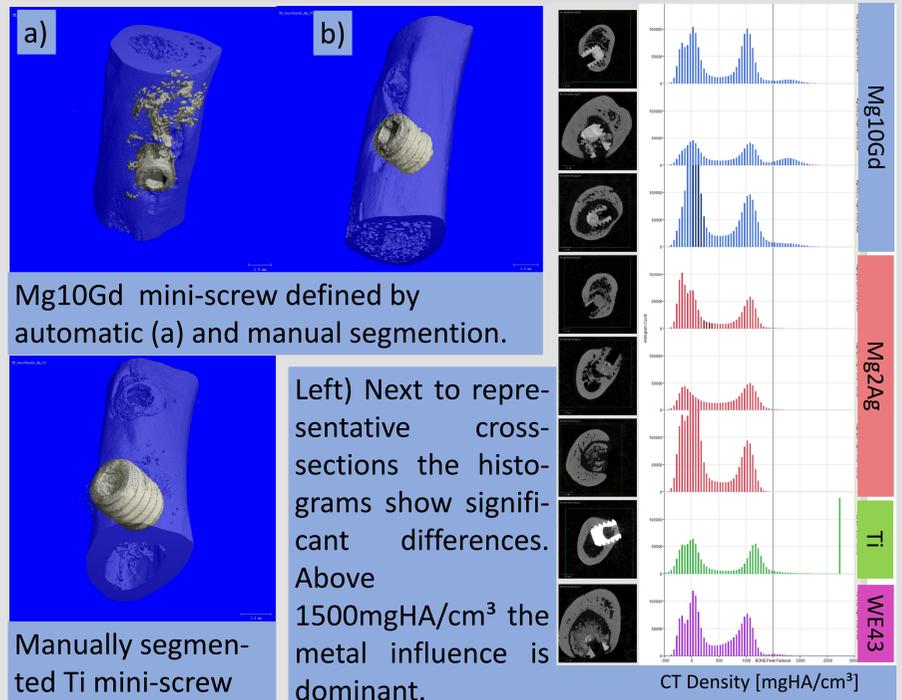
Compared to Ti-implants, imaging of Mg-alloys in μ CT is less affected by metal artefacts, so the extraction of meaningful density profiles around the implants is feasible using our *in-vivo* μ CT system.
